# LAB REPORT

## A.SCOPE

The scope of the lab report is to describe the test of Sherardized coated nails with coating thickness of 50-60 microns, in Salt Spray cabinet conforms to ASTM B-117 for 1000 hours, and watch the results.

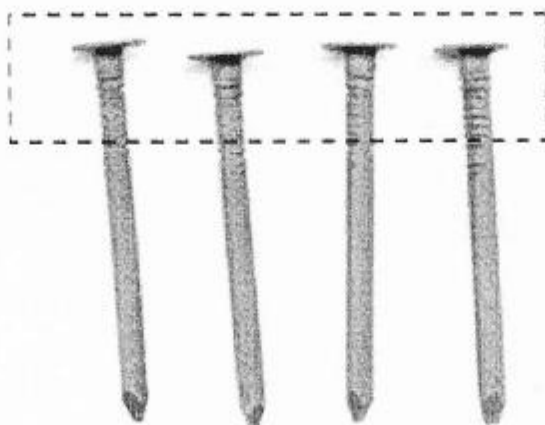
Nails was tested to red spots by hanging them as in the following picture. The neck of the nails is the best and easiest way to hold the nails in the cabinet.

The nails was held by polyethylene piece with holes which the nails lean through it as seen in the table below refer to 0 time.

The spot where the  
fasterers are fixed

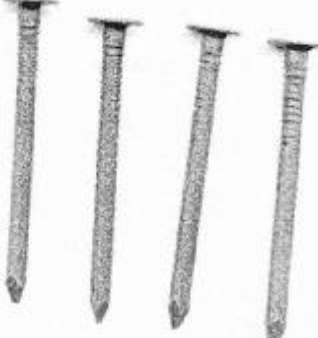
TIME	% Red spots area	Nail Picture
0	0

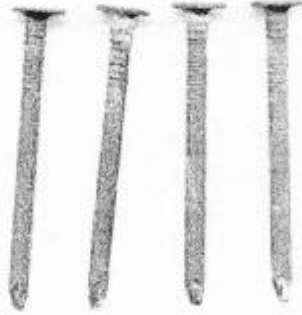
168	0

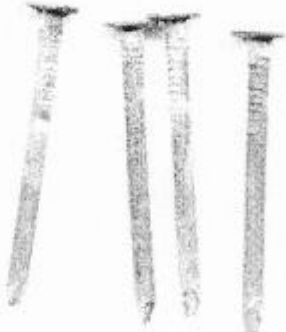
672	4.6

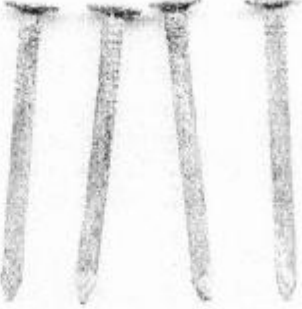
1000	8.2

Final results showed that 8.2% area of the Sherardized coated nails, covered with red spots.

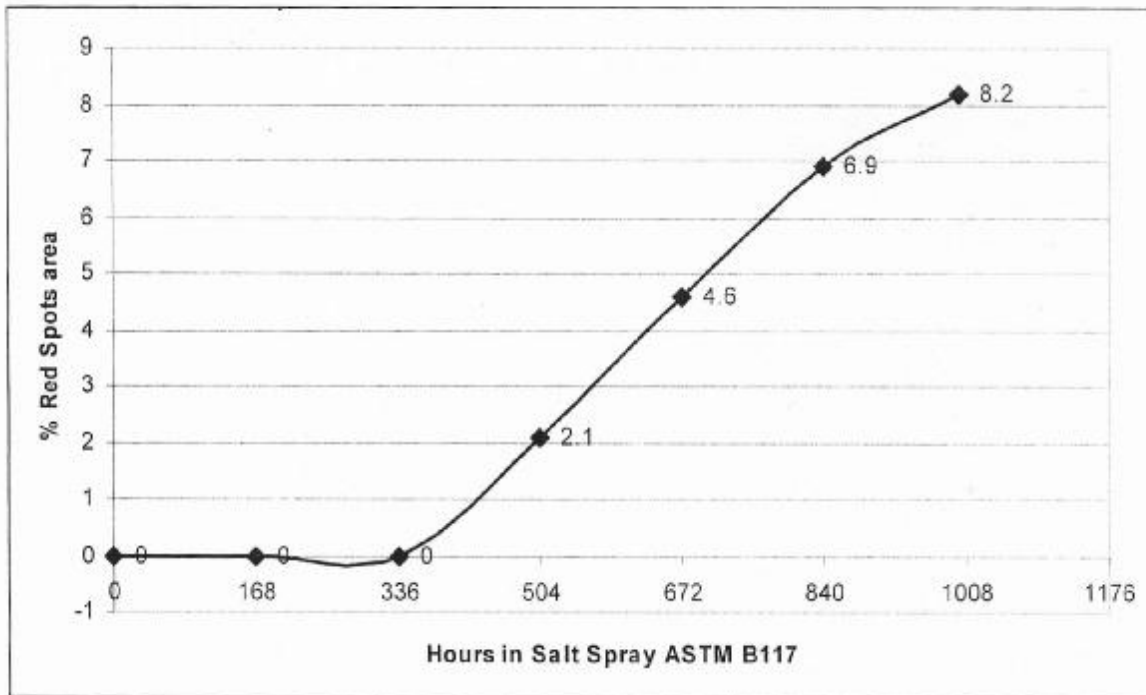
Graficaly we can exhibit as follow:
